**LTPP Seasonal Monitoring  
Program**  
Site Monitoring Suspension  
Status Report  
Section 893015  
Trois Rivieres, Quebec

# SEASONAL MONITORING PROGRAM SUSPENSION STATUS REPORT

## QUEBEC SECTION 893015

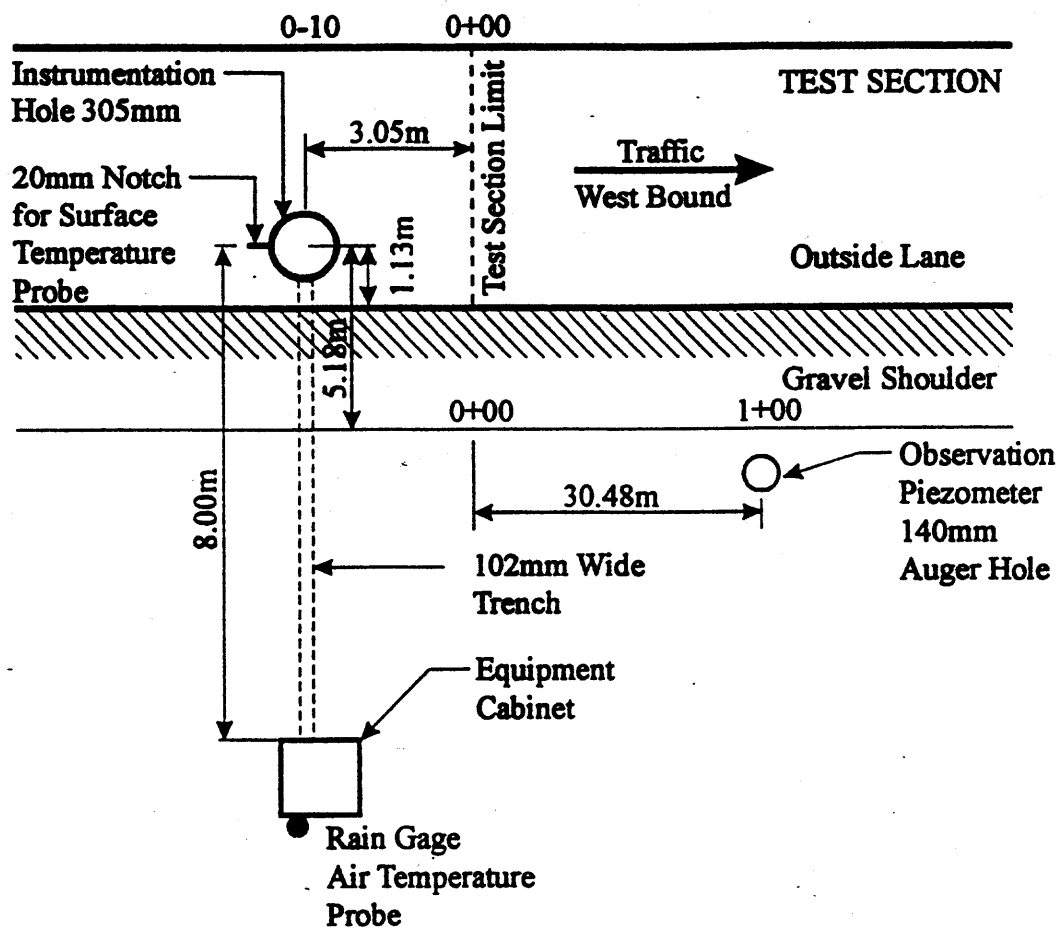
Figure 1. Location for Seasonal Monitoring Instrumentation Installed at GPS 893015

Figure 1 shows the locations of the installed instrumentation at the site. The instrumentation hole is at Station 0-10 and the piezometer is at Station 1+00. Table 2 gives the elevations of the portion of test section 893015 that was used for elevation measurements. All offsets are measured from the outside pavement edge.

- Height of Air Temperature Probe (center): 3.43m
- Height of Tipping Bucket Rain Gage (center): 3.35m
- Total Depth of Piezometer: 4.29m
- Distance of Piezometer Below Ground Level: 254mm

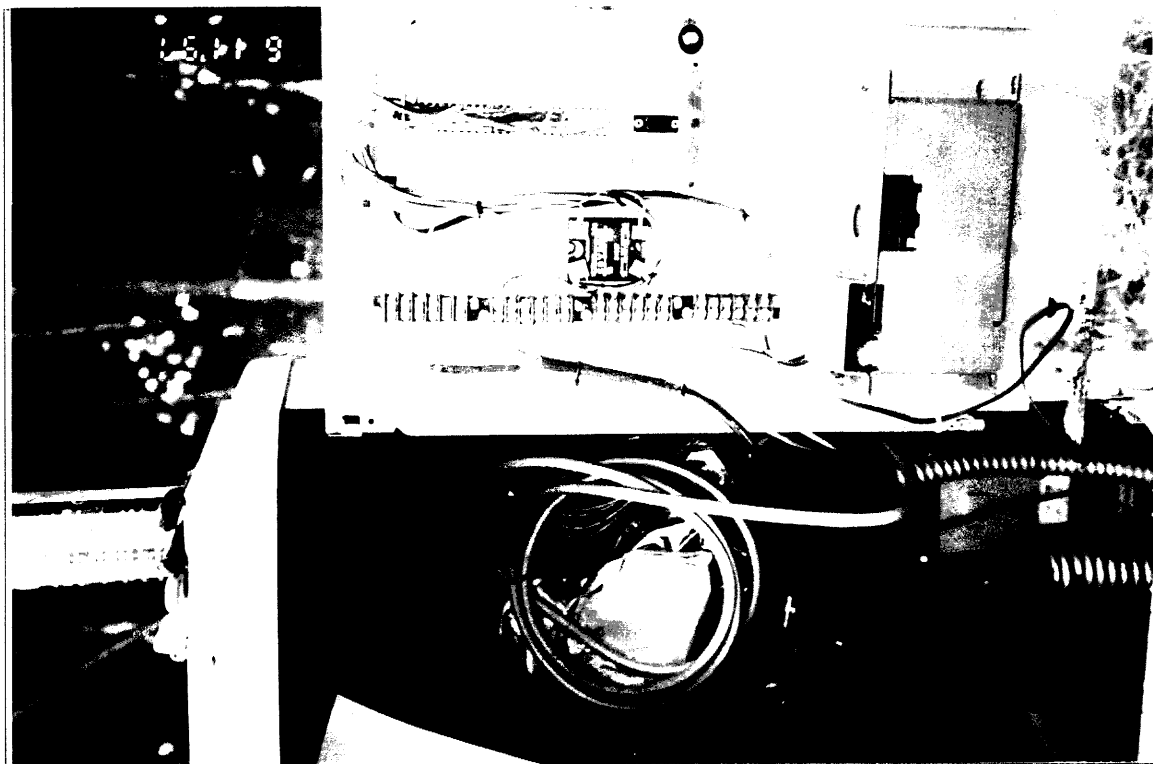
Inside Equipment Cabinet, Seasonal Site 893015 - November 1997 after Round 2  
Data Collection Activities were completed

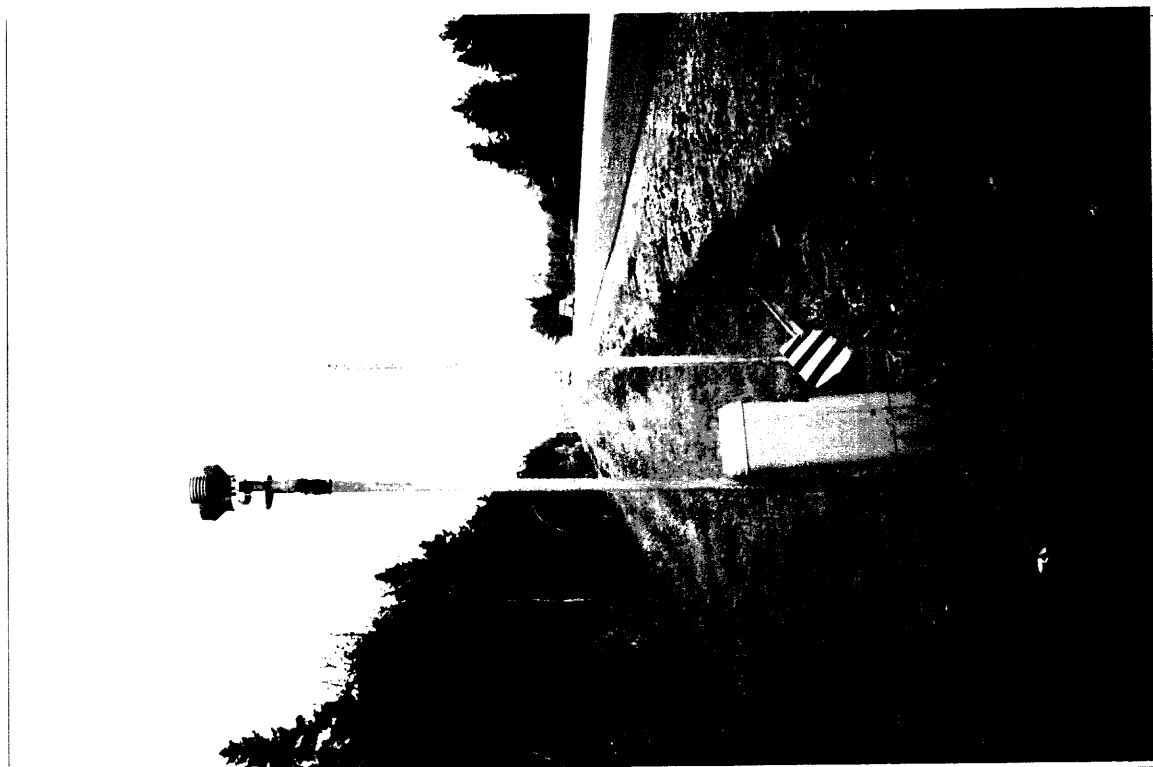
Equipment Cabinet, Solar Panel, Instrument Pole, Seasonal Site 893015 -November 1997, after  
Round 2 Data Collection Activities were completed
